PROJECT No.: SM 200232-E

**PHASE ONE ENVIRONMENTAL SITE ASSESSMENT
KILLALY SITE
PORT COLBORNE, ONTARIO**

**SOIL-MAT ENGINEERS & CONSULTANTS LTD.
130 LANCING DRIVE
HAMILTON, ONTARIO
L8W 3A1**

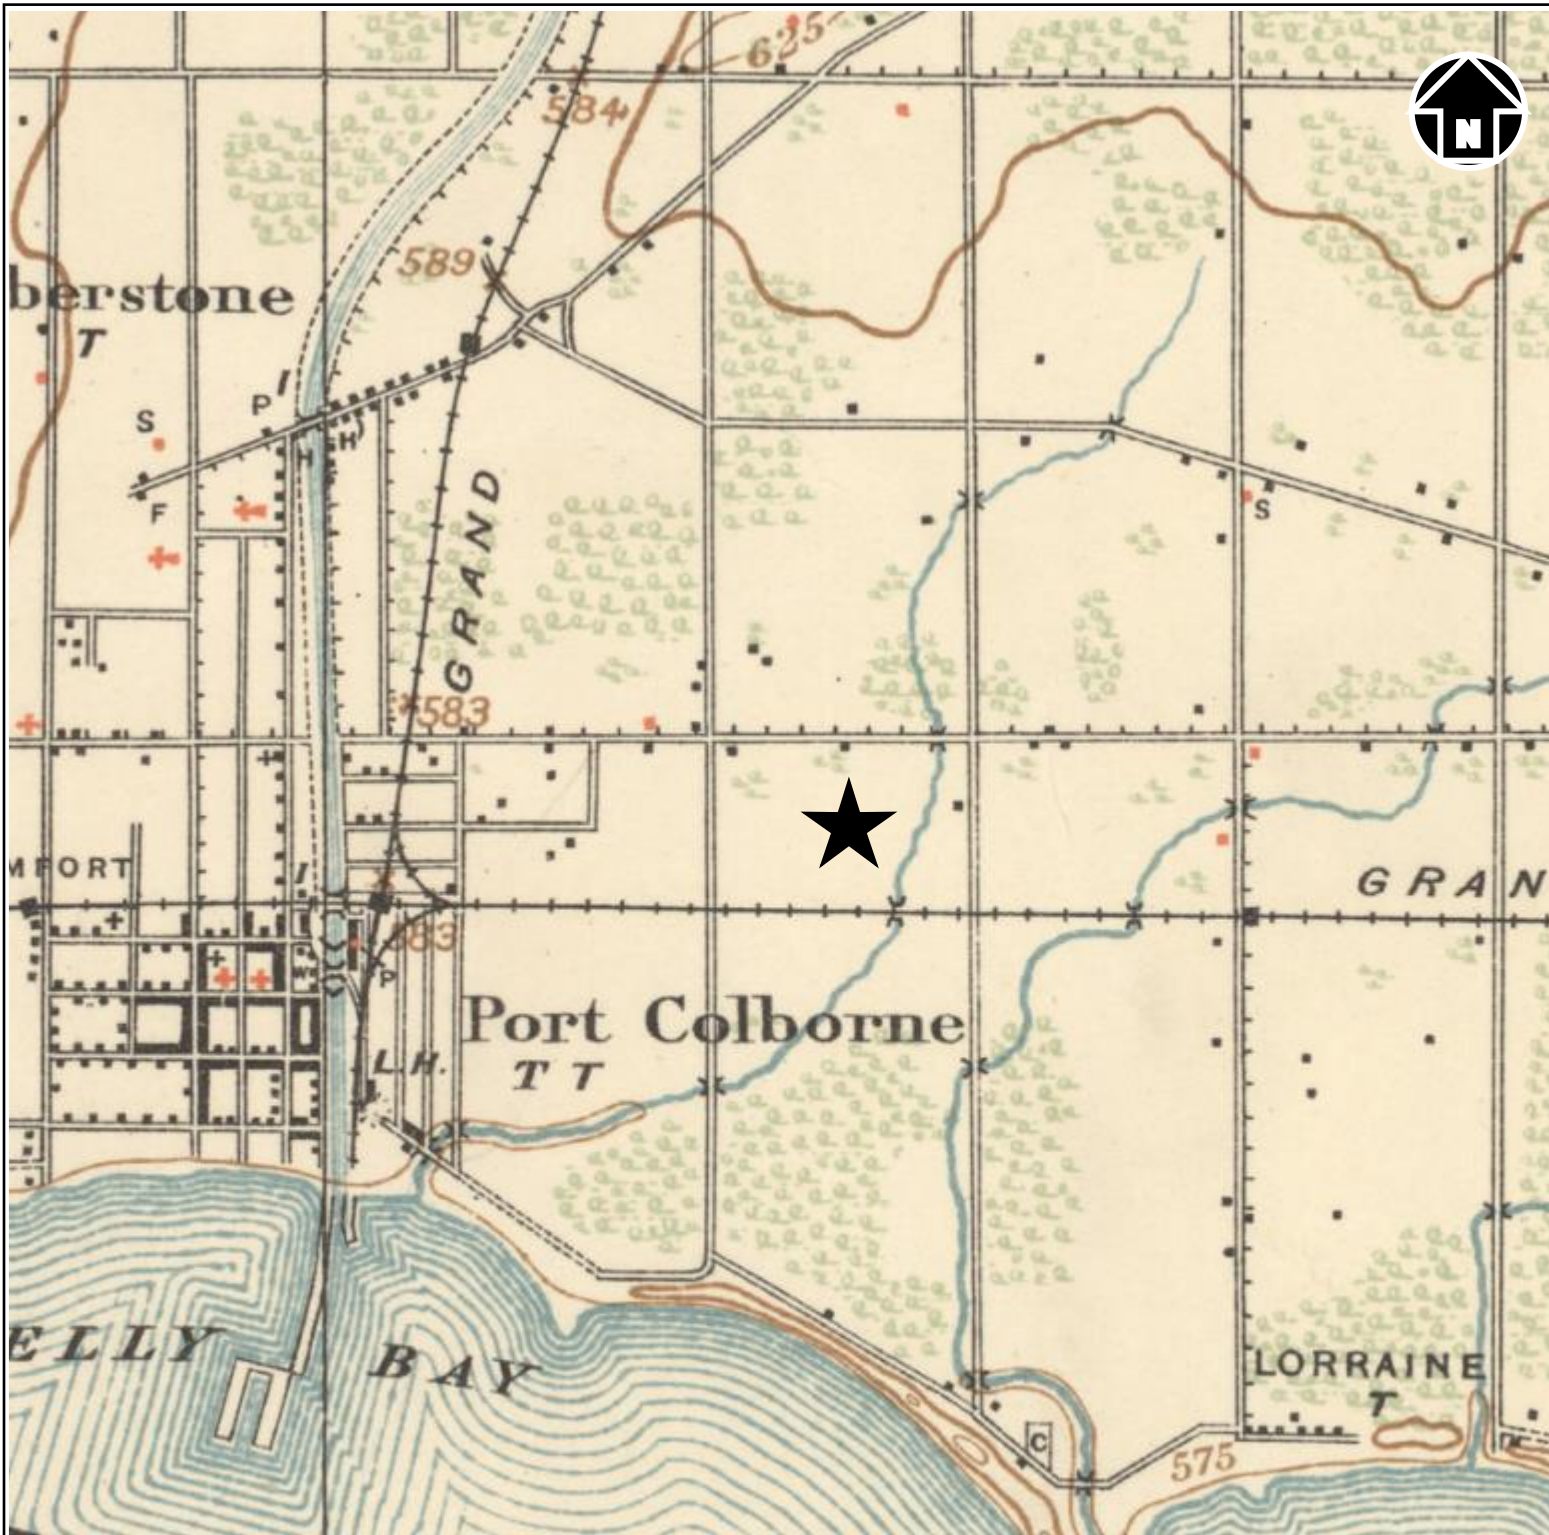
DRAWING No. 4a

1. 1906 Topographic Map;
2. 1938 Topographic Map;
3. 1964 Topographic Map, and;
4. 1996 Topographic Map.
